**Flood Control Project Maintenance
Levee Inspections**

Maintenance Issue Types Only, Levee Inspection Report By Mile - Fall 2018

Marysville Levee Commission

Waterway	Bank	Unit Miles	Inspection Start/End	Inspector
Unit No. 01 Simmerly Slough	Left	3.23	10/31/2018 10/31/2018	Sterling York

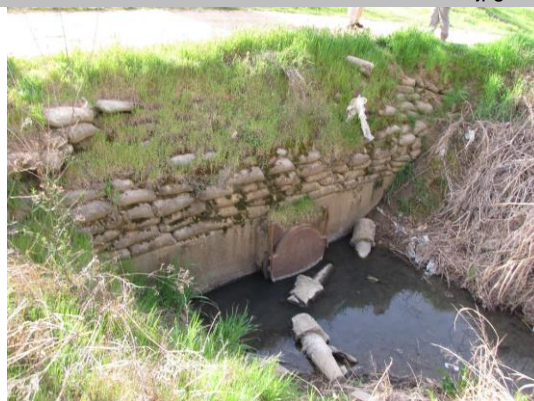
Photo 1 of 3 : UCIP_FA_2018_52792_69744.jpg

Comment Code					
Inspector Comment					
FS_ID:52792					
DS_ID:19090					
EP_NO: N/A					
Repair Type: No Action Needed					
Crossing Status: Found					
UCIP Comments:					
FIELD_STRUCT_DESC: 36-inch corrugated metal drainage pipe through levee, 27 feet below crown. Flap gate and concrete "U" headwall on waterside (WS) end. Slide gate in 48-inch corrugated metal riser on WS slope of pipe. Steel walkway to control gate. Outfall drains from Ellis Lake. Concrete headwall at both toes. Concrete base under riser units. Steel riser unit and slide gate added under Permit No. 4041, 1962-Marysville Levee Commission. [Additional Reference(s): DWR Levee Logs, 1993 and 2005. USACE Sacramento O&M Manual Unit No. 147, August 1955, (Station 8+48)]					
FS Date: 3/14/2013

View of outlet located on waterward side under toe road.

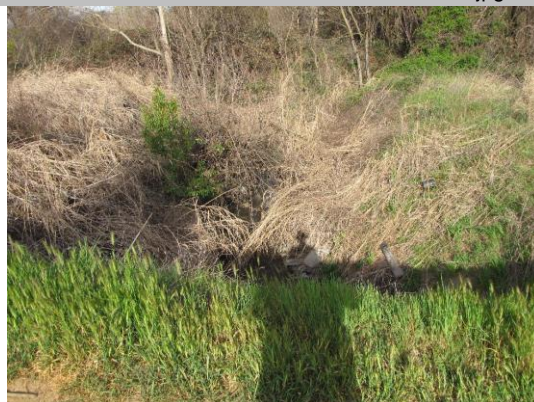
Photo 2 of 3 : UCIP_FA_2018_52792_69743.jpg

View of waterward side from toe road.

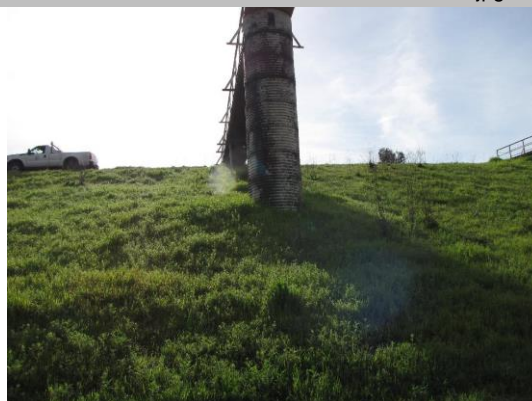
Photo 3 of 3 : UCIP_FA_2018_52792_69742.jpg

Comment Code						
Inspector Comment						
FS_ID:52792						
DS_ID:19090						
EP_NO: N/A						
Repair Type: No Action Needed						
Crossing Status: Found						
UCIP Comments:						
FIELD_STRUCT_DESC: 36-inch corrugated metal drainage pipe through levee, 27 feet below crown. Flap gate and concrete "U" headwall on waterside (WS) end. Slide gate in 48-inch corrugated metal riser on WS slope of pipe. Steel walkway to control gate. Outfall drains from Ellis Lake. Concrete headwall at both toes. Concrete base under riser units. Steel riser unit and slide gate added under Permit No. 4041, 1962-Marysville Levee Commission. [Additional Reference(s): DWR Levee Logs, 1993 and 2005. USACE Sacramento O&M Manual Unit No. 147, August 1955, (Station 8+48)]						
FS Date: 3/14/2013

View of waterward slope.

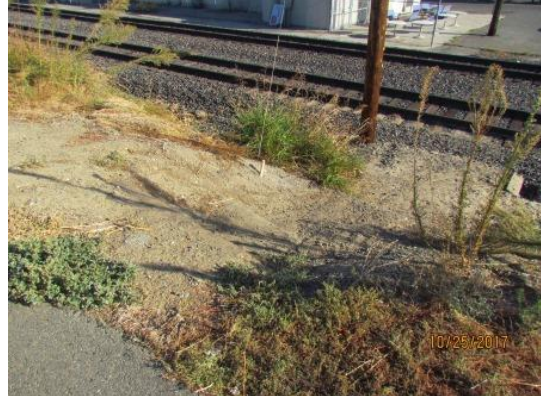
Photo 1 of 1 : FA_2018_NA0004_105_14_20180918_00005.jpg

LM Start	0.85	Rating **	M	Issue No.	14
LM End	0.85	Issue Type +	Ma	Location *	LS
Category	Earthen Levee			GPS Latitude/Longitude	
				Start	End
Item	Slope Stability			39.138463 °	39.138463 °
				-121.599168 °	-121.599168 °
DWR ID	DWR_NA0004_02_f_2016_14				
Comment Code					
S2 : Repair the levee slope damaged by foot traffic and prevent access where possible.					
Inspector Comment					
Remove steps that are cut into levee slope, Fall 2017.

View of steps for foot path in the landside levee slope.

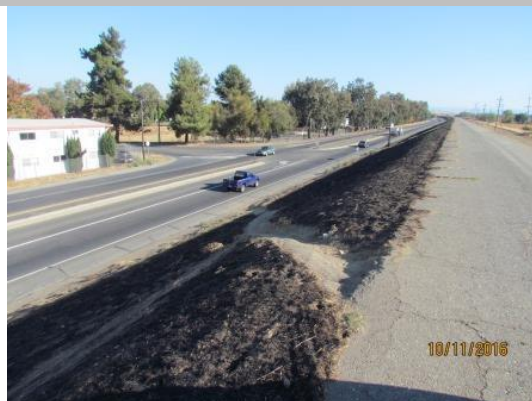
Photo 1 of 1 : FA_2018_NA0004_106_39_20180918_00011.jpg

LM Start	2.15	Rating **	M	Issue No.	39
LM End	2.15	Issue Type +	Ma	Location *	LS
Category	Earthen Levee			GPS Latitude/Longitude	
				Start	End
Item	Slope Stability			39.154440 °	39.154440 °
				-121.569839 °	-121.569839 °
DWR ID	DWR_NA0004_03_f_2016_39				
Comment Code					
S2 : Repair the levee slope damaged by foot traffic and prevent access where possible.					
Inspector Comment					
Erosion from foot traffic should be repaired, Spring 2018.

View looking upstream of foot path that has cut into the landside levee slope.

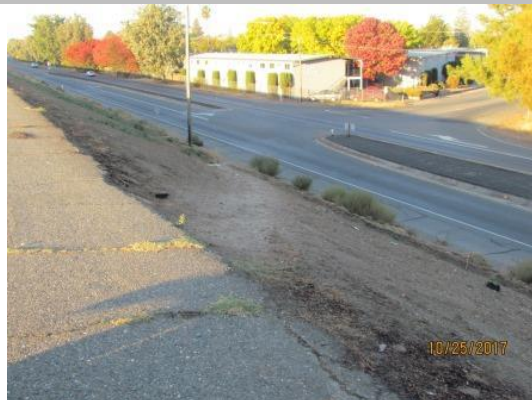
Photo 1 of 1 : FA_2018_NA0004_106_40_20180918_00012.jpg

LM Start	2.21	Rating **	M	Issue No.	40
LM End	2.21	Issue Type +	Ma	Location *	LS
Category	Earthen Levee			GPS Latitude/Longitude	
				Start	End
Item	Slope Stability			39.155076 °	39.155076 °
				-121.568970 °	-121.568970 °
DWR ID	DWR_NA0004_03_f_2016_40				
Comment Code					
S2 : Repair the levee slope damaged by foot traffic and prevent access where possible.					
Inspector Comment					
Ruts from foot traffic should be repaired.

View looking downstream landside of foot path that is cut into the landside levee slope.

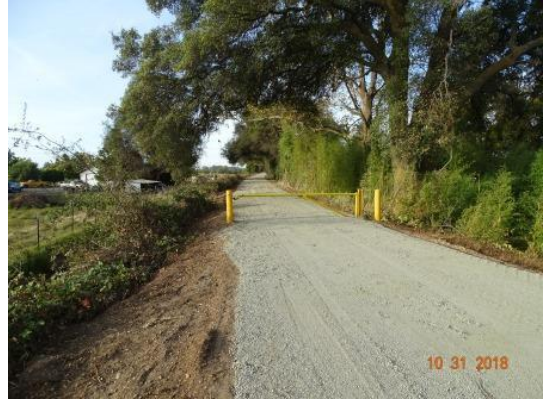
Photo 2 of 2 : FA_2018_NA0004_106_17_20181108_00047.jpg

LM Start	3.52	Rating **	A	Issue No.	17 (cont)
LM End	6.78	Issue Type +	Ma	Location *	CR
Category	Earthen Levee			GPS Latitude/Longitude	
				Start	End
Item	Crown Surface / Depressions / Rutting			39.170162 °	39.202383 °
				-121.554591 °	-121.511191 °
DWR ID	DWR_NA0004_03_f_2018_17				
Comment Code					
C3 : Add appropriate gravel or road base. Grade and compact.					
Inspector Comment					
Patrol road resurfaced, Fall 2018.

View looking upstream at the end of patrol road resurfaced with aggregate base, Fall 2018.
